UNITED STATES OF AMERICA
BEFORE THE NUCLEAR REGULATORY COMMISSION

_____)	
In the Matter of:)	
<i>Florida Power & Light Co.</i>)	Docket No. 50-389
St. Lucie Plant, Unit 2)	November 6, 2014
_____)

**SOUTHERN ALLIANCE FOR CLEAN ENERGY'S
MOTION FOR LEAVE TO AMEND HEARING REQUEST
WITH SECOND SUPPLEMENTAL DECLARATION OF ARNOLD GUNDERSEN**

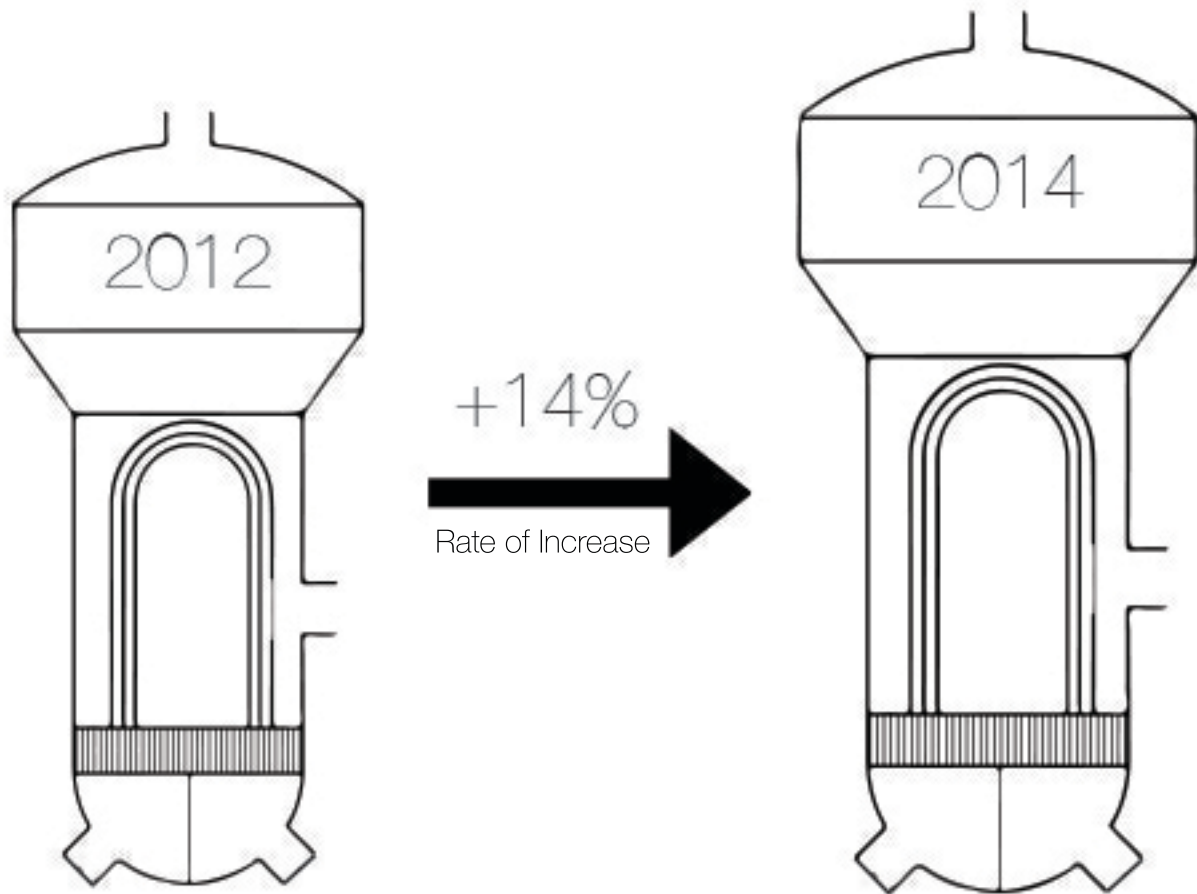
Table 1

10. In March 2014, FPL conducted a 100% steam generator tube inspection in SG A and SG B. The results of the inspection show that during the 18-month period between the 2012 and the 2014 outages and inspections, tube denting indications in SG A increased by 4% of the total tubes (from 31% to 35%). In SG B, tube

denting increased from 18% to 22% of the total tubes for a net increase of 4%. The rate of increased denting indications between 2012 and 2014 was 14% for SG A and 17% for SG B. A detailed breakdown of the number of tubes that were found dented in 2012 compared to the number of tubes that were found dented in 2014 is attached to this report and labeled as Tables 1 and 2.

St. Lucie Unit 2 : **A** Steam Generator Tube Denting Indications

Total Steam Generator Tubes with Tube Denting Indications at Anti-Vibration Bar

Year	Steam Generator	# of tubes	% of tubes (8,999 total)	Change since previous year	% Increase over previous inspection
2012	A	2,809	31%		
2014	A	3,207	35%	+398	14%

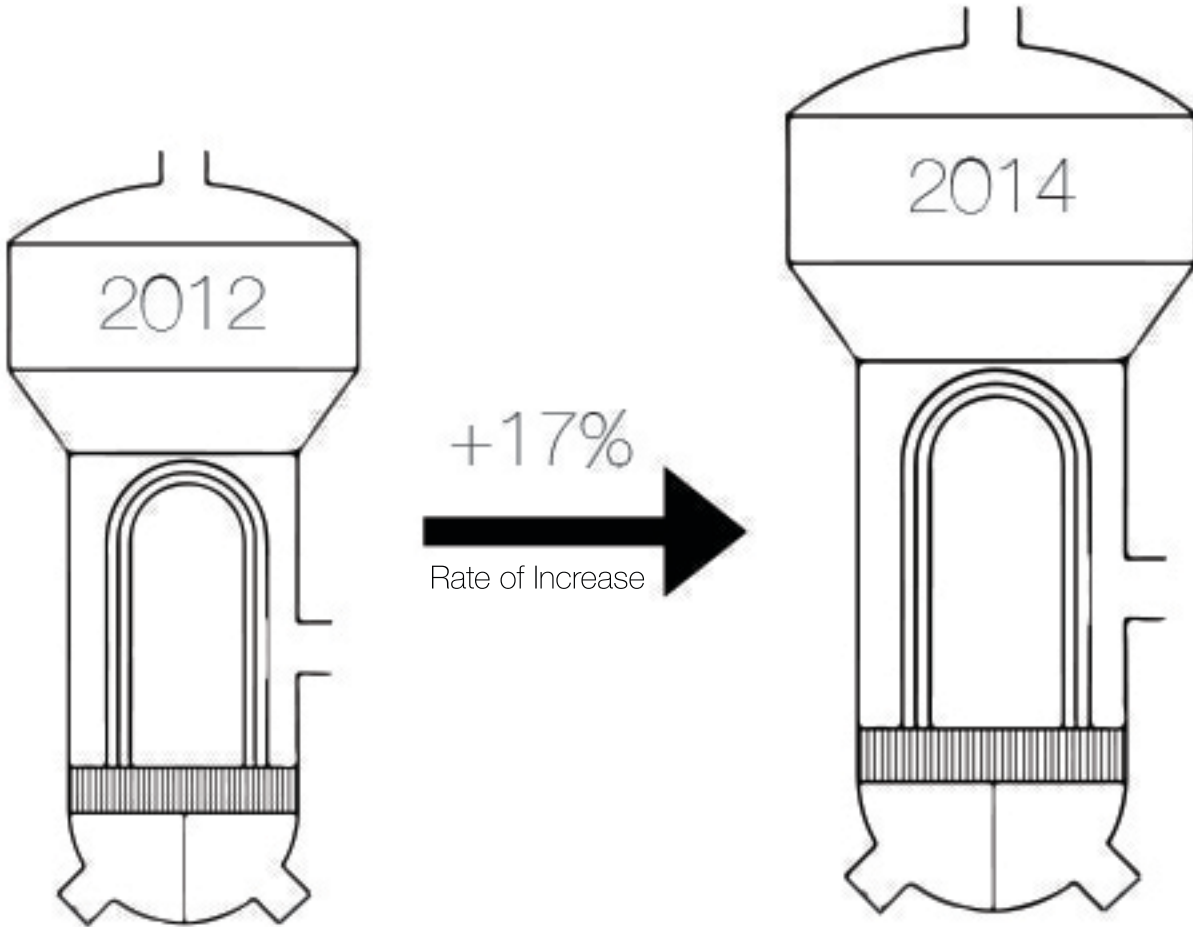
Table 2

St. Lucie Unit 2 : **B** Steam Generator Tube Denting Indications

Total Steam Generator Tubes with Tube Denting Indications at Anti-Vibration Bar

Year	Steam Generator	# of tubes	% of tubes (8,999 total)	Change since previous year	% Increase over previous inspection
2012	B	1,656	18%		
2014	B	1,938	22%	+282	17%

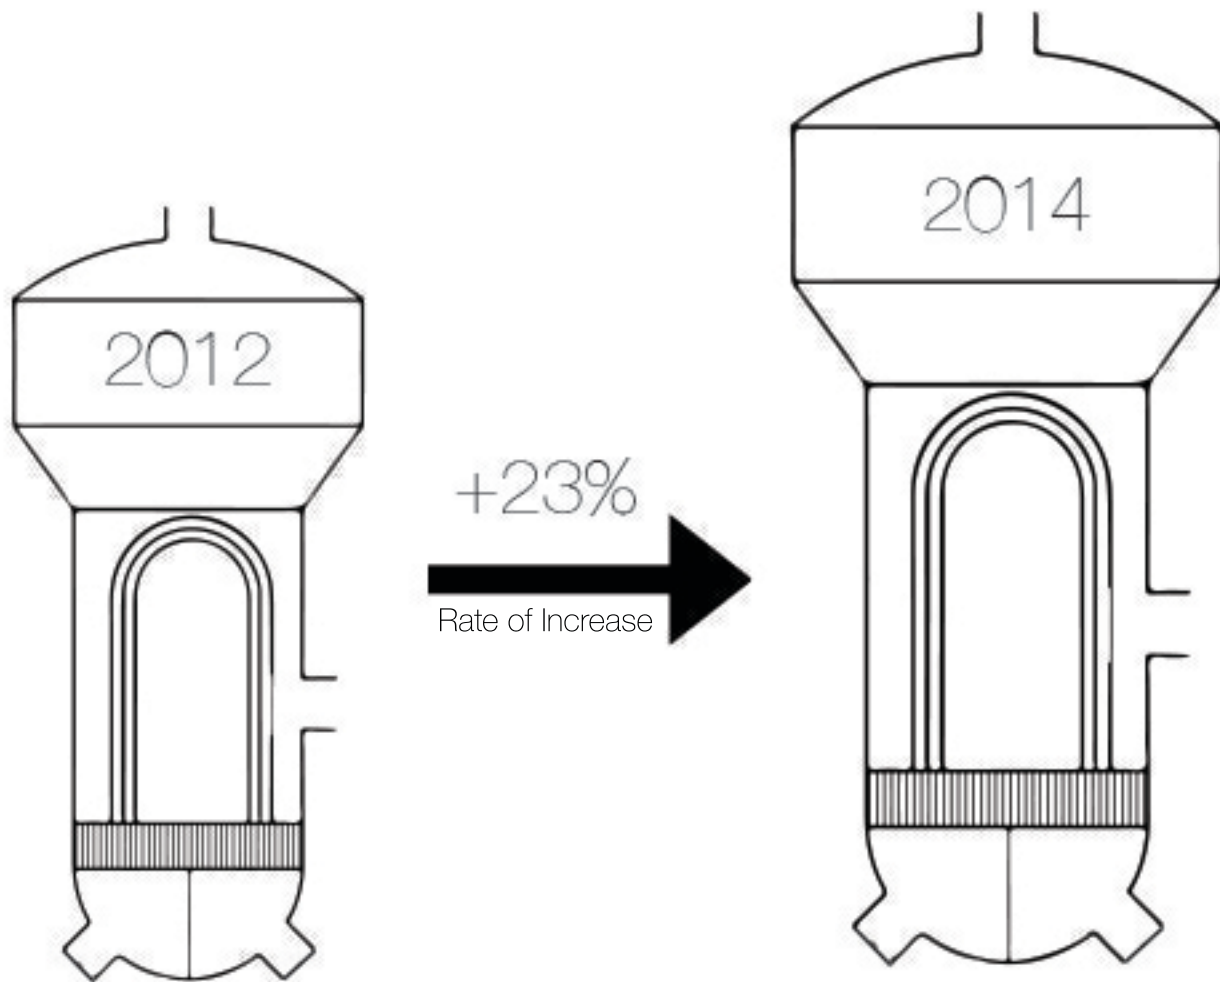
Table 4

St. Lucie Unit 2 : **B** Steam Generator
 Serious Tube Damage

Steam Generator Tubes with Serious Anti-Vibration Bar Damage (> 20%)

Year	Steam Generator	# of tubes (8,999 Total)	% of tubes	Change since previous year	% Increase over previous inspection
2012	B	126	1.4%		
2014	B	157	1.7%	+31	23%

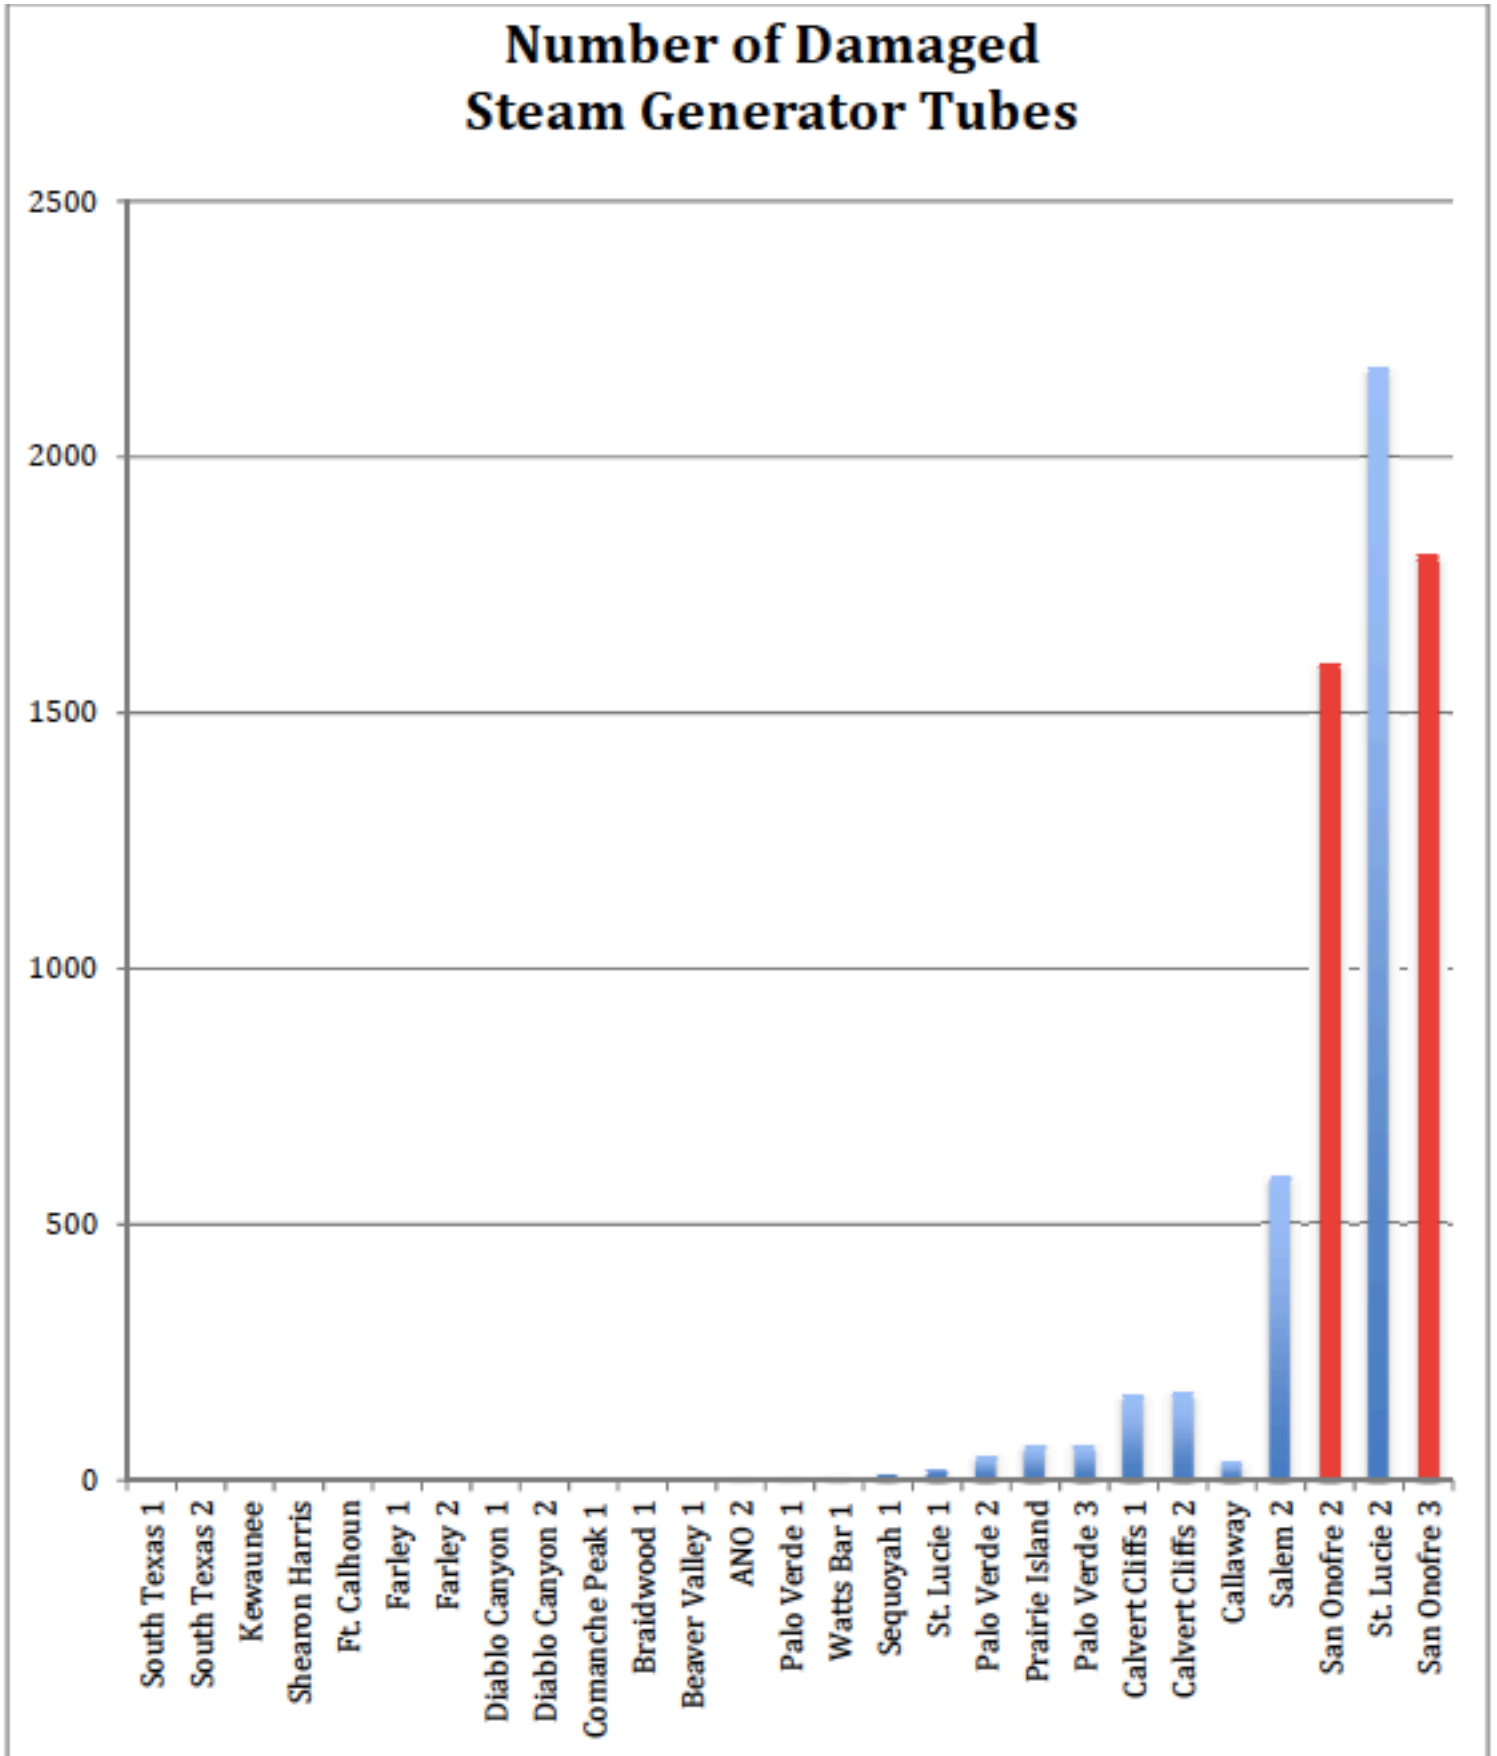
14. I am concerned that the rate of steam generator tube deterioration in St. Lucie Unit 2, although decreased from previous outages, continues to be extraordinarily high compared to other steam generators nationwide. Figure 1 shows that most reactors experience little or no steam generator degradation throughout time periods of operation spanning decades. During the normal operating lifetime of a steam generator, the rate of degradation during its operating life is not likely to exceed 4% of the total tubes in the entire steam generator. In comparison, the percent of increased damage experienced by the St. Lucie Unit 2 SG A during just the last 18 months between inspections is 4% and the total damage in only 6-years is 35%.
